DEVELOPMENT OF REPAIR PROCESSES  
AND SOURCES FOR C/KC-135 AIRCRAFT  
WINDOWS/WINDSHIELDS

RICHARD J. OLSON

BATTELLE  
505 KING AVENUE  
COLUMBUS, OH 43201

SEPTEMBER 1994

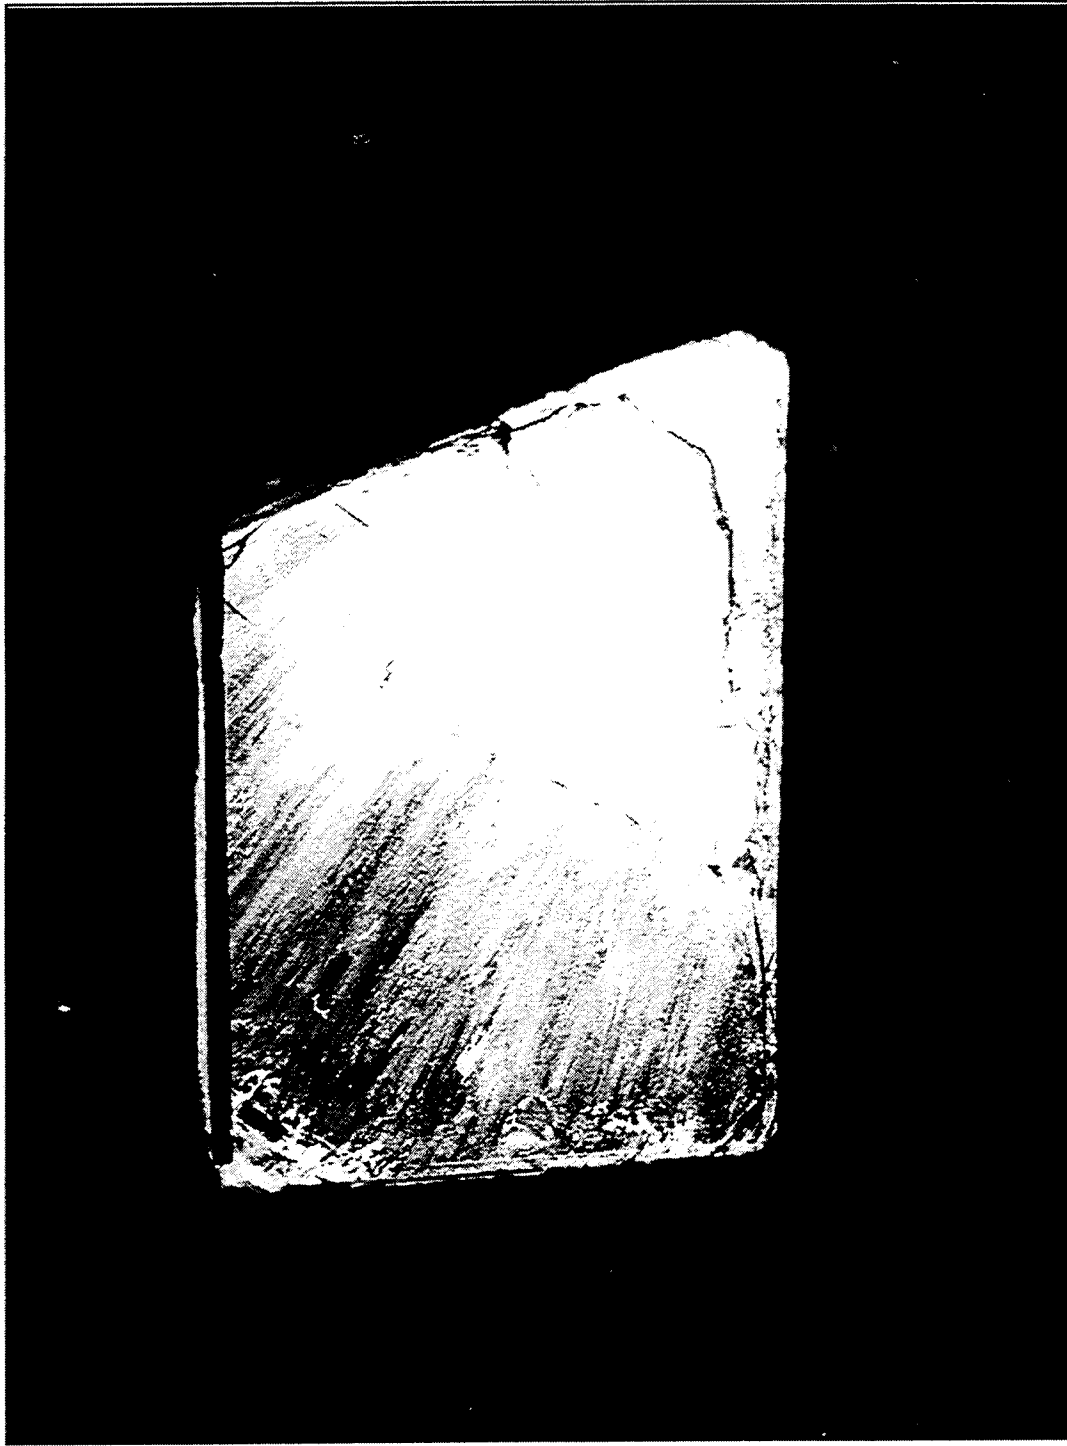
Figure 4.37 C/KC-135 #4 W/WS Showing Outboard Ply Failure From a 4-Pound Bird Impact at 247.5 Knots,  
Rear View (Repaired W/WS, S/N B75-1149)

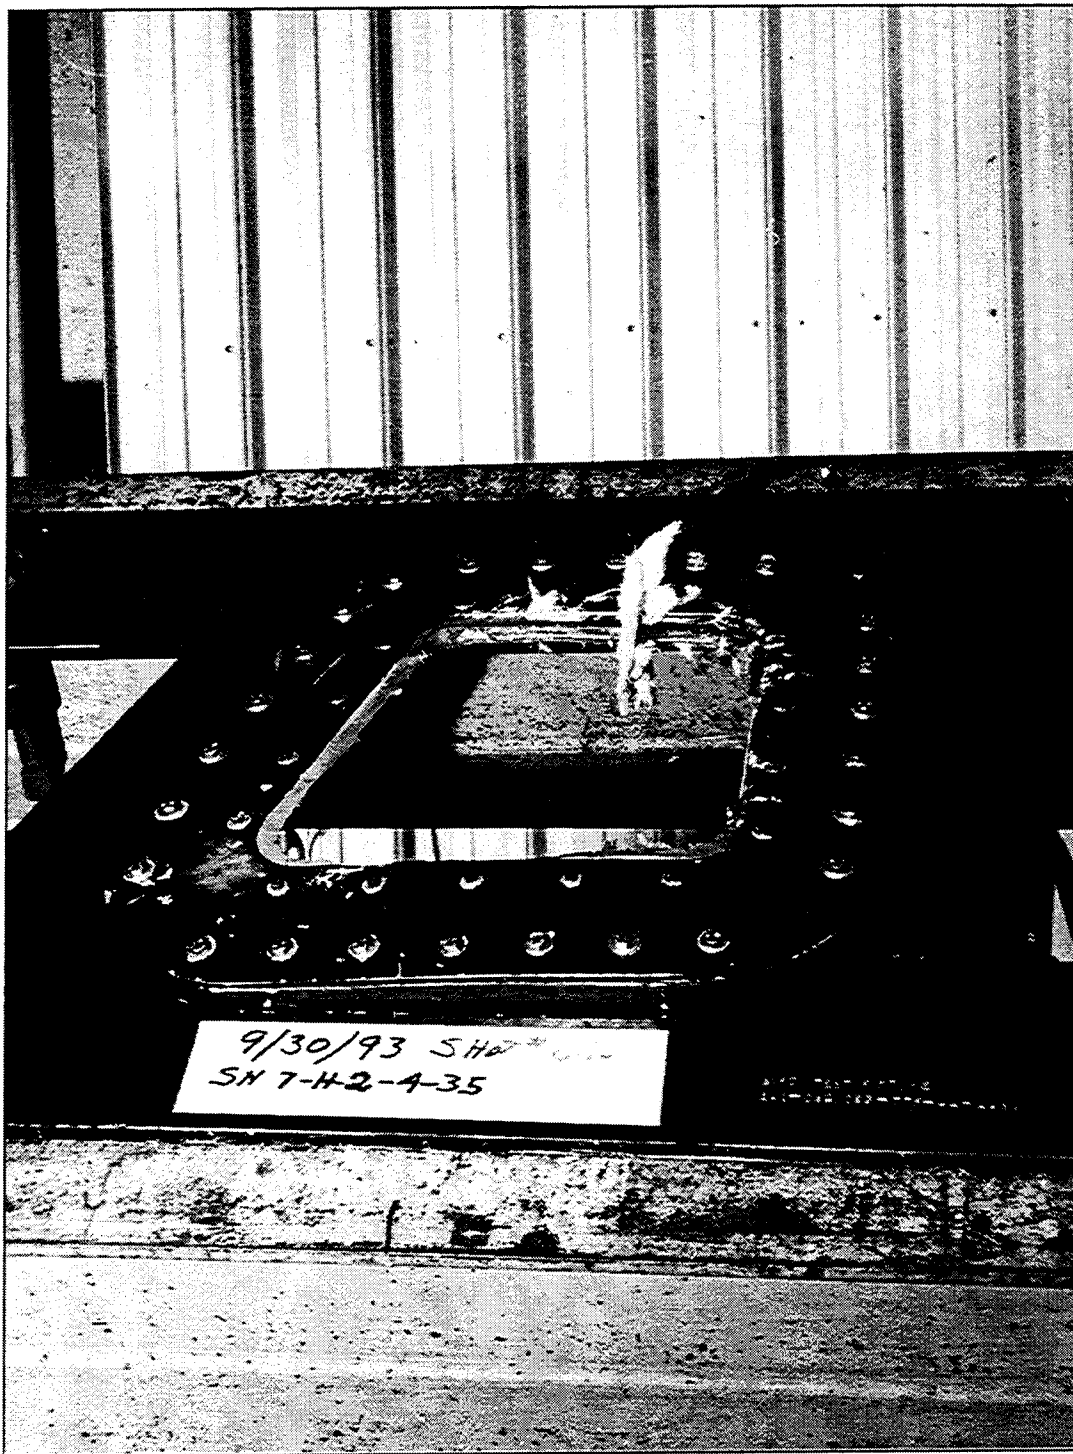
Figure 4.38 C/KC-135 #4 W/WS Showing a Catastrophic All Glass Plies Failure From a 4-Pound Bird Impact at 250.8 Knots, Front View (Not Repaired W/WS, S/N 7-H-2-4-35)

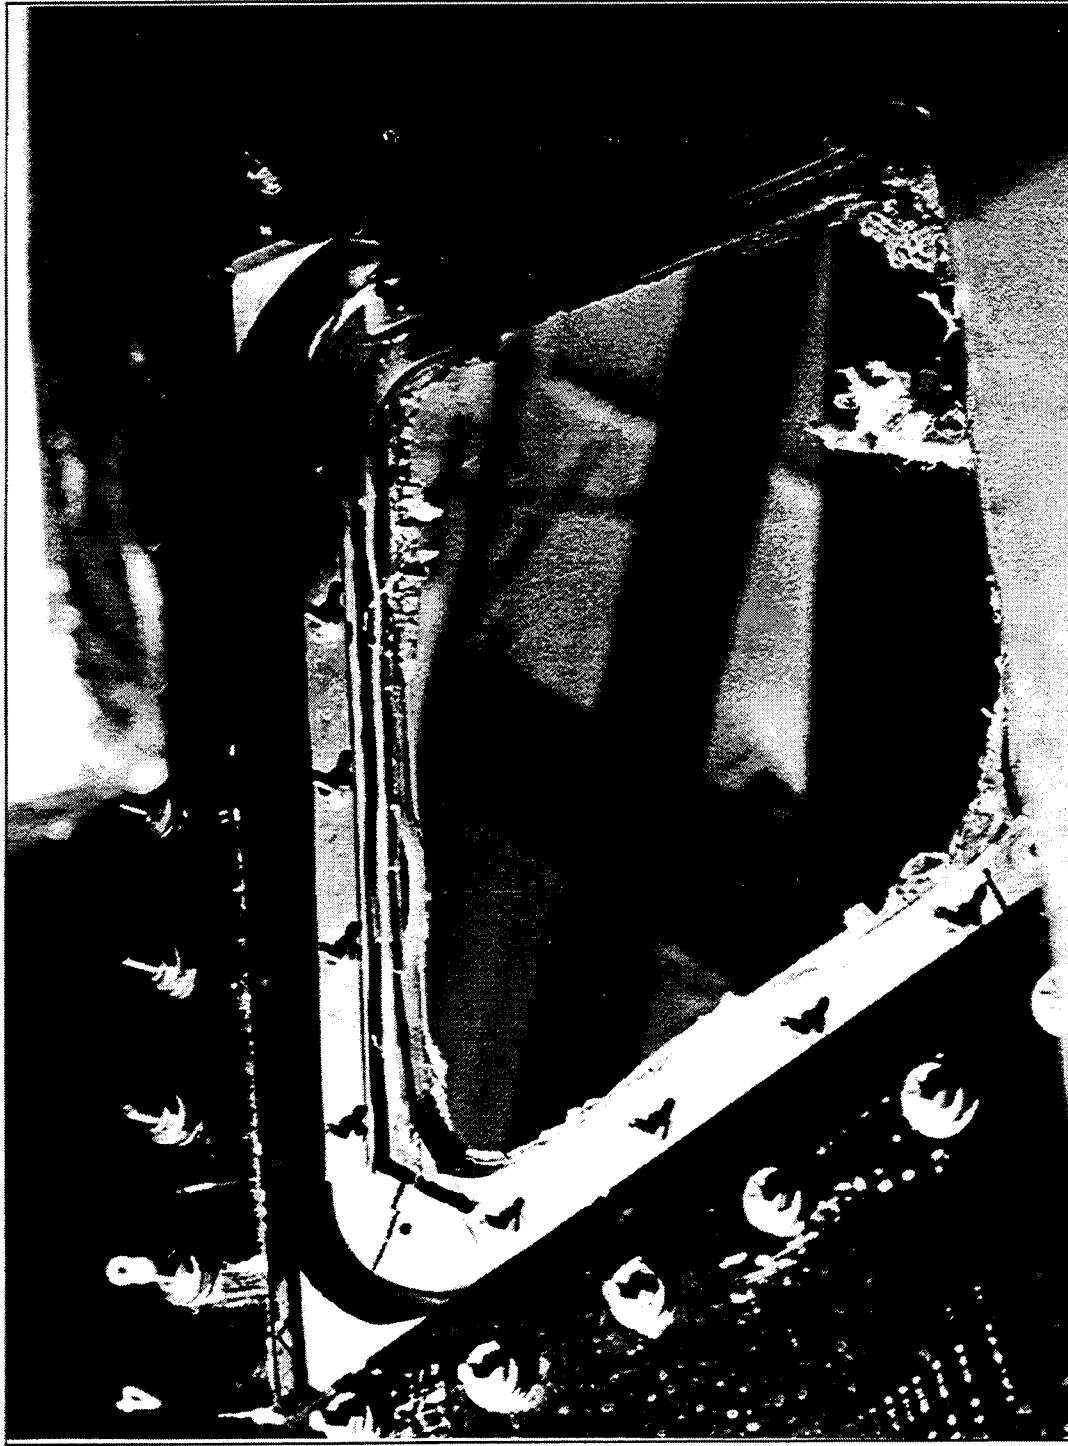
Figure 4.39 C/KC-135 #4 W/WS Showing a Catastrophic All Glass Piles Failure From a 4-Pound Bird Impact at 250.8 Knots, Rear View (Not Repaired W/WS, S/N 7-H-2-4-35)

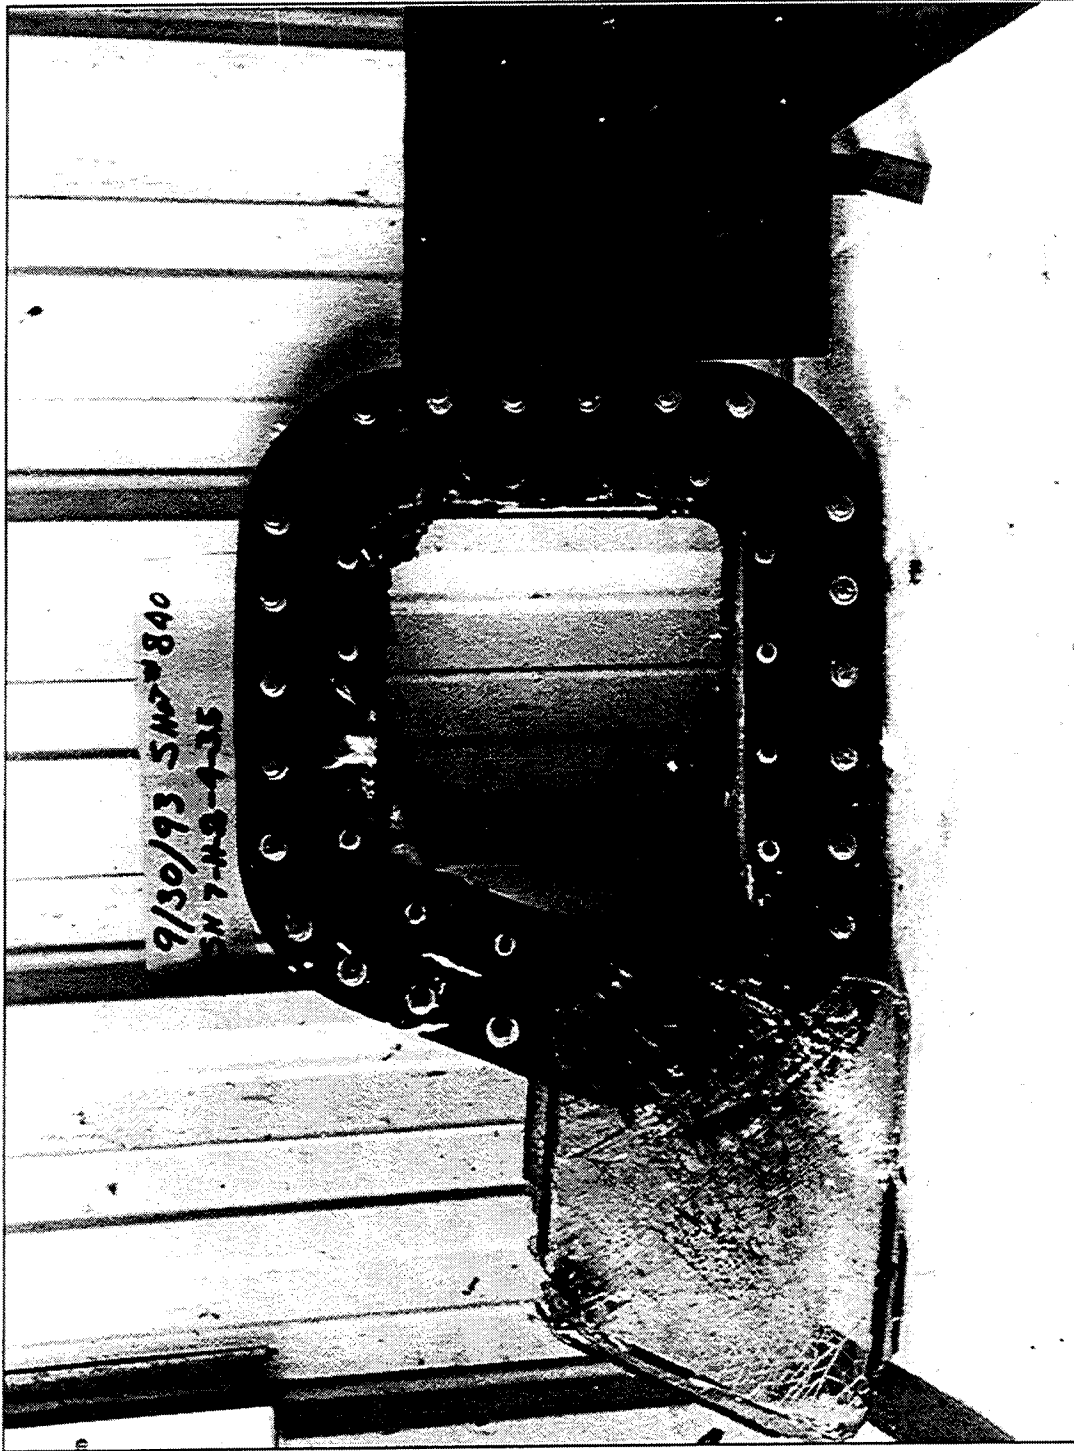
Figure 4.40 Spall Sheet and W/WS Condition From a Catastrophic 4-Pound Bird Impact at 250.8 Knots on a C/KC-135 #4 W/WS (Not Repaired W/WS, S/N 7-H-2-4-35)

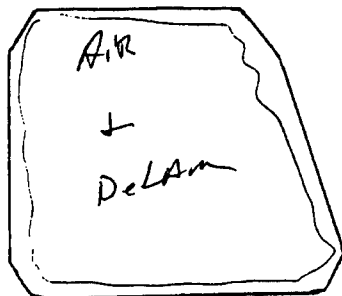
Visual Inspection Map & Comments

AIR And DeLAM is located ALL AROUND  
unit.

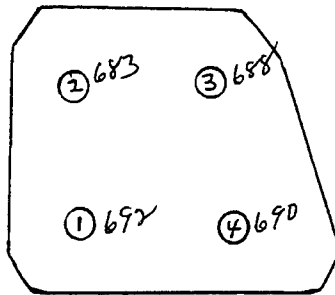
Seal Loose AS MARKED

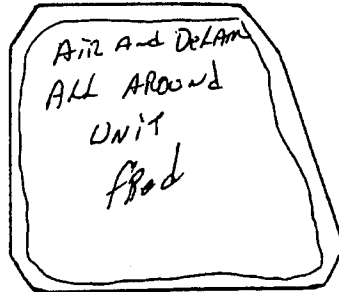
Visual Inspection Map & Comments

1: <u>.684</u> 2: <u>.679</u> 3: <u>.685</u> 4: <u>.679</u>			
Check for Vinyl Cracks:	<u>Acc</u>	<u>JUN 03 1993</u>	<u>22 PPG 77</u>
Seal Evaluation:	<u>ReJ</u>	<u>JUN 03 1993</u>	<u>22 PPG 77</u>
(Comments) <u>WRONG SEAL ON OUTSIDE</u>			
Visual Inspection:	<u>ReJ</u>	<u>JUN 03 1993</u>	<u>22 PPG 77</u>
(Place comments on attached sheet)

Air And DeLam ALL AROUND Edge of Unit

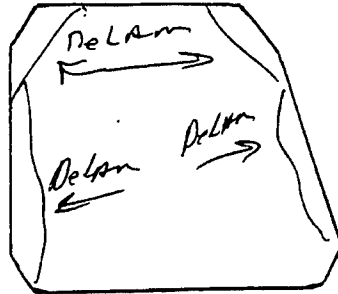
Visual Inspection Map & Comments

De Lam And Air All Around ~~it~~

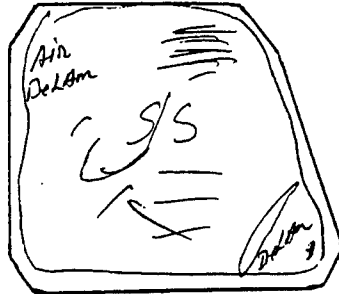
Visual Inspection Map & Comments

Seal Evaluation:	<u>Rej</u>	<u>JUN 03 1993</u>	<u>22 PPG 77</u>
(Comments) <u>BAD SEAL AND BUMPER</u>			
Visual Inspection: (Place comments on attached sheet)	<u>Rej</u>	<u>JUN 03 1993</u>	<u>22 PPG 77</u>

BAD SURFACE SCR LOCATED THROUGHOUT THE UNIT  
BOTH SIDE

AIR AND DeLAM LOCATED ALL AROUND UNIT

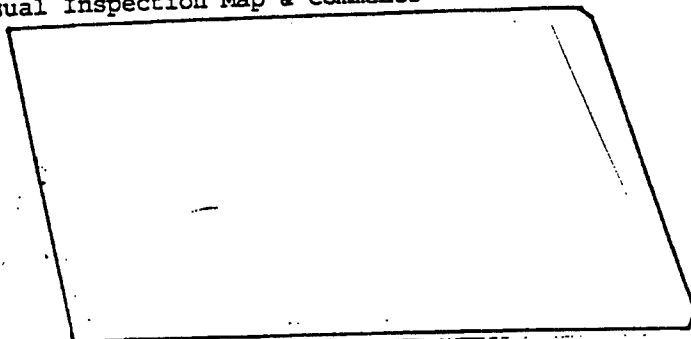
Visual Inspection Map & Comments

Some AIR

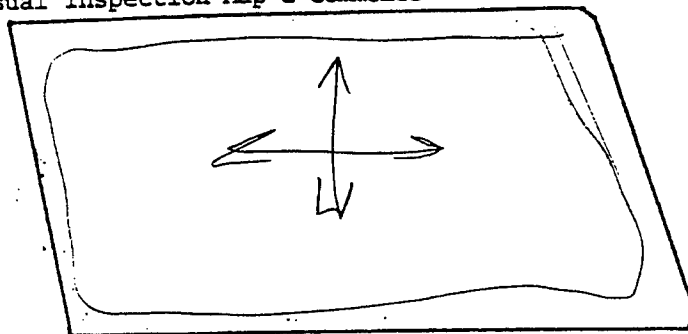
Visual Inspection Map & Comments

AIR, Delam And WATER JUST ABOUT ALL THE WAY AROUND UNIT

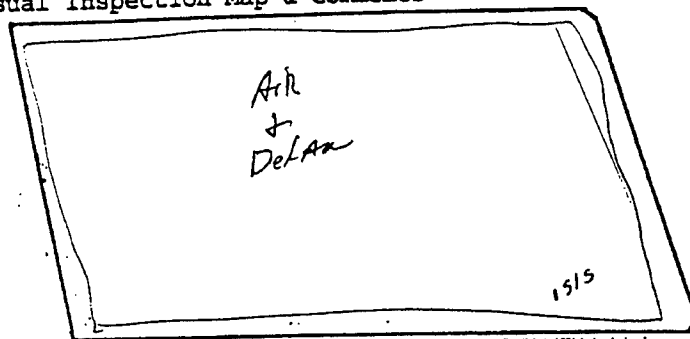
Visual Inspection Map & Comments

AIR & Delam located ALL AROUND UNIT

SURFACE SCR located BOTTOM AT Edge of UNIT

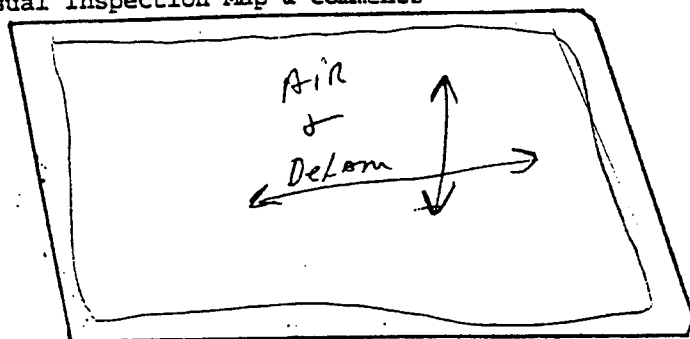
Visual Inspection Map & Comments

AIR and DeLam LOCATED ALL AROUND THE UNIT

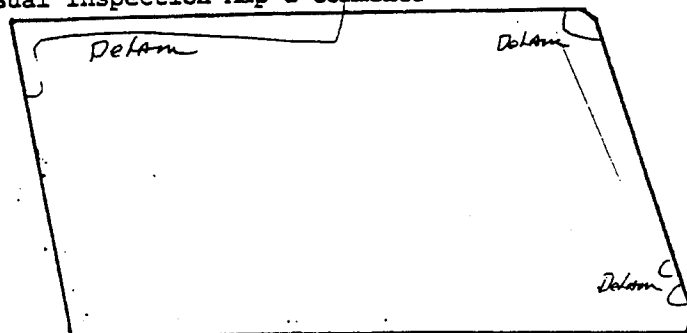
Visual Inspection Map & Comments

Delam Along TOP And Right Edge of Unit

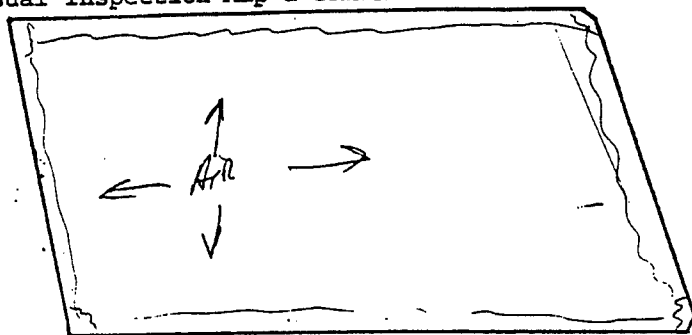
AIR ALL ALONG THE EDGE OF UNIT.

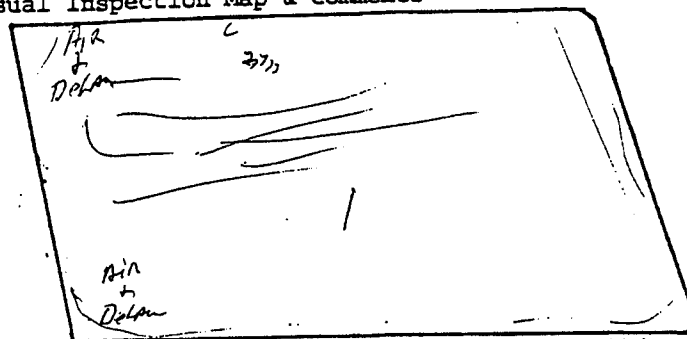
Air And Delam AROUND THE UNIT.

SURFACING PER ALL OVER THE OUTSIDE side of UNIT

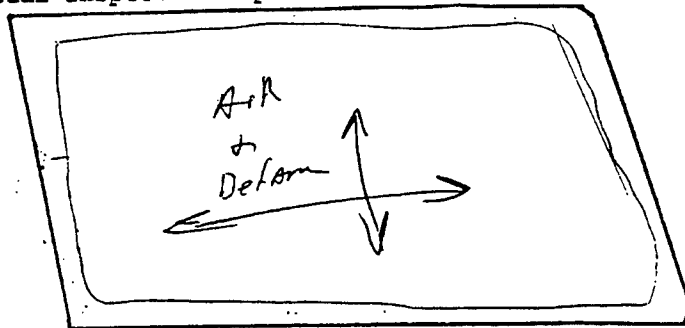
AIR & Delam LOCATED ALL AROUND UNIT.

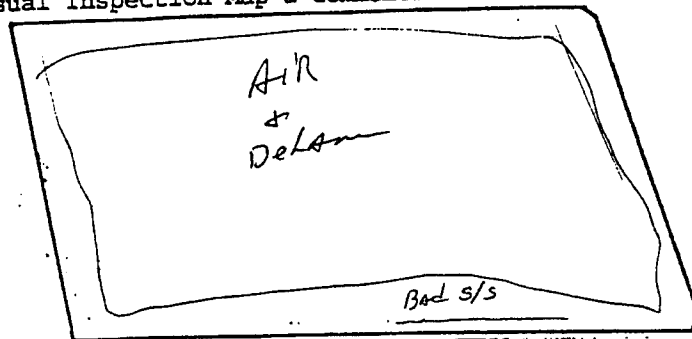
AIR + Delam LOCATED AROUND THE UNIT.  
VERY BAD SURFACE SCR LOCATED BOTTOM FRONT EDGE

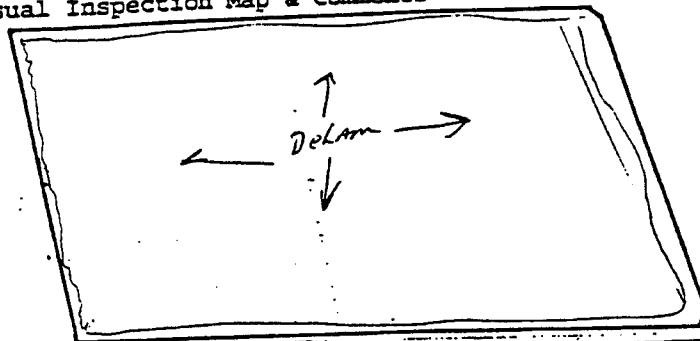
DeLam Located ALL AROUND the UNIT

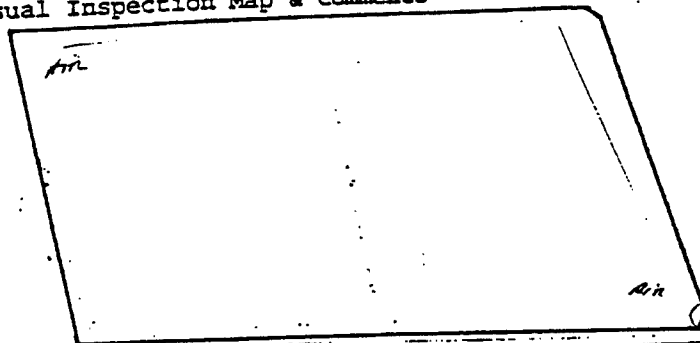
AIR starting above edge of unit

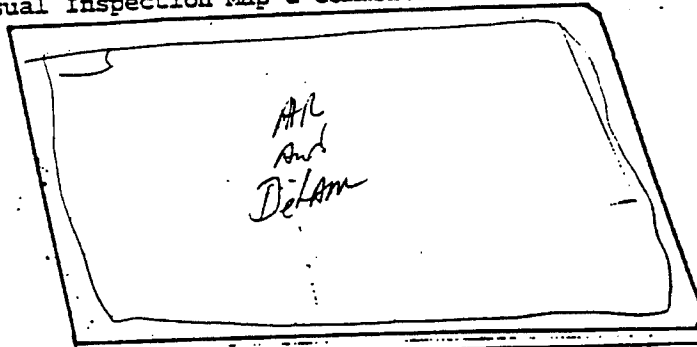
UNIT HAS AIR/DeLam LOCATED THROUGHOUT.

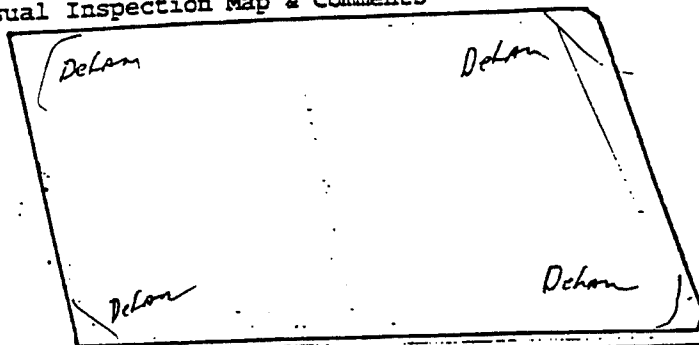
Delam located in ALL FOUR CORNERS

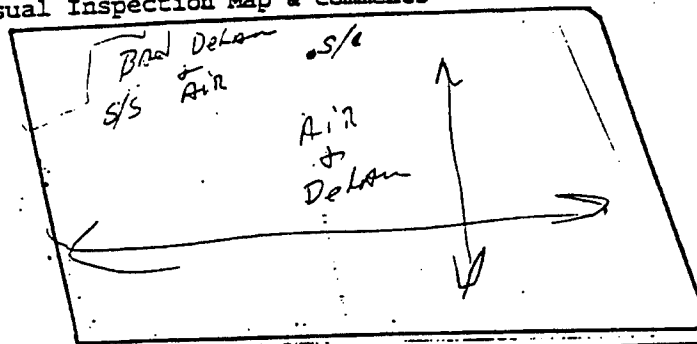
Air and Delam LOCATED ALL AROUND UNIT  
 SURFACE SCR LOCATED AS MARKED  
 SURFACE CHIP LOCATED AS MARKED

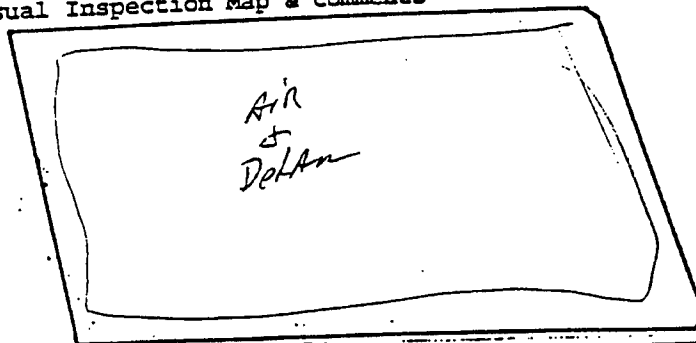
AIR And DeLAM LOCATED AROUND THE LIMIT

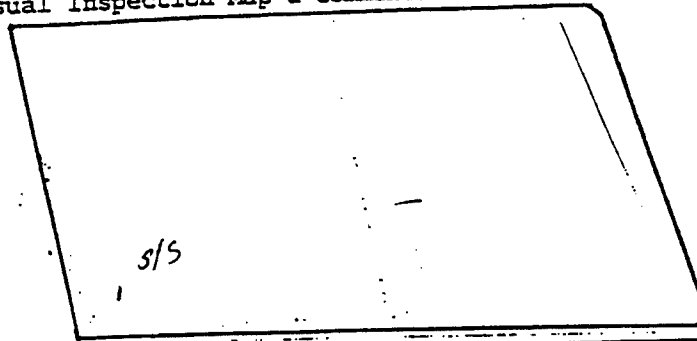
SURFACE SCR LOCATED AS MARKED

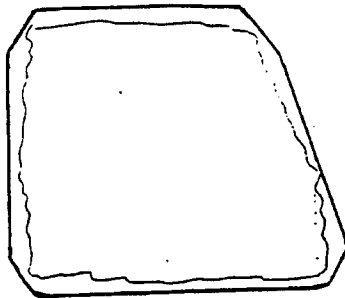
1: <u>4</u> 2: <u>10</u> 3: <u>7</u> 4: <u>4</u>			
Dimensional Inspection: _____			
Unit Thickness: (Per Template)			
1: <u>74.693</u> 2: <u>70.0</u> 3: <u>69.5</u> 4: <u>69.2</u>			
Check for Vinyl Cracks: _____	<u>Acc</u>	<u>JUN 02 1993</u>	<u>22 PPG 77</u>
Seal Evaluation: _____	<u>ReJ</u>	<u>JUN 02 1993</u>	<u>22 PPG 77</u>
(Comments) * <u>OPEN circuit</u> <u>wrong seal on OUTSIDE</u> <u>inside sealant</u>			
Visual Inspection: _____ (Place comments on attached sheet)	<u>ReJ</u>	<u>JUN 02 1993</u>	<u>22 PPG 77</u>

open Power Circuit

UNIT HAS AIR ALL ROUND THE UNIT

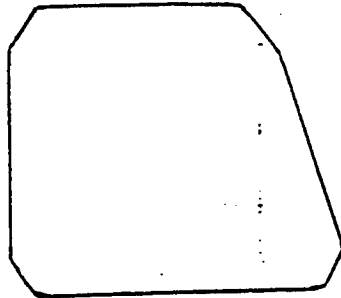
1: <u>.646</u> 2: <u>.642</u> 3: <u>.644</u> 4: <u>.644</u>			
Check for Vinyl Cracks:	<u>Acc</u>	<u>JUN 02 1993</u>	<u>22 PPG 77</u>
Seal Evaluation:	<u>Rej</u>	<u>JUN 02 1993</u>	<u>22 PPG 77</u>
(Comments)	<u>wrong type of seal on outbd side</u> <u>Bad <del>seal</del> open circuit sometime A</u> <u>Reading and other times NO Reading</u>		
Visual Inspection:	<u>Acc</u>	<u>JUN 02 1993</u>	<u>22 PPG 77</u>
(Place comments on attached sheet)

*Open Power Circuits*

*wrong type of seal on outboard side*

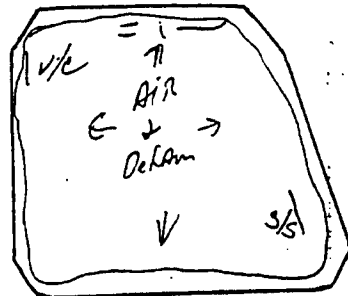
9/5

1: <u>.642</u> 2: <u>.643</u> 3: <u>.684</u> 4: <u>.686</u>			
Check for Vinyl Cracks:	<u>Rej</u>	<u>JUN 03 1993</u>	<u>22 PPG 77</u>
Seal Evaluation:	<u>Rej</u>	<u>JUN 03 1993</u>	<u>22 PPG 77</u>
(Comments)	<u>BAD Seal &amp; Bumper on outside</u>		
Visual Inspection:	<u>Rej</u>	<u>JUN 03 1993</u>	<u>22 PPG 77</u>
(Place comments on attached sheet)

AIR & DeLam = Located ALL AROUND UNIT

Vinyl CRACK located AS MARKED

SURFACE SCR located AS MARKED

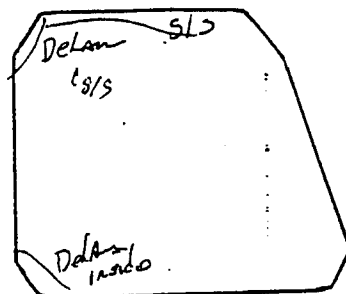
(Comments) <u>BRD Brumley</u>			
Visual Inspection: <u>ReS</u> (Place comments on attached sheet)		<u>JUN 03 1993</u>	<u>22 PPG 77</u>

AIR And DelAm located Around the end  
 Surface Scr. location As marked

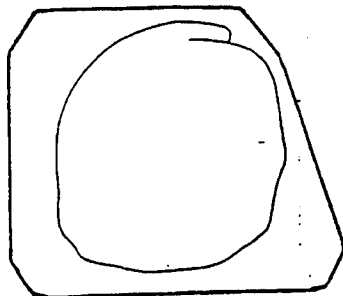
1: <u>.677</u> 2: <u>.678</u> 3: <u>.679</u> 4: <u>.676</u>			
Check for Vinyl Cracks:	<u>ReS</u>	<u>JUN 03 1993</u>	<u>22 PPG 77</u>
Seal Evaluation:	<u>ReS</u>	<u>JUN 03 1993</u>	<u>22 PPG 77</u>
(Comments) <u>NO seal on bumper</u>			
Visual Inspection: (Place comments on attached sheet)	<u>ReS</u>	<u>JUN 03 1993</u>	<u>22 PPG 77</u>

Air / Delam / Viny Cracks Located All  
AROUND UNIT

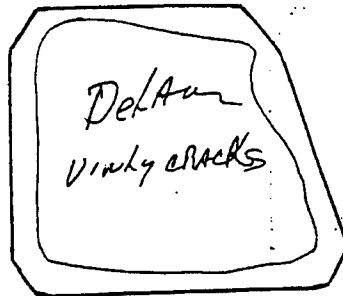
Visual Inspection Map & Comments

1: <u>.666</u> 2: <u>.666</u> 3: <u>.664</u> 4: <u>.665</u>			
Check for Vinyl Cracks:	<u>Pass</u>	<u>JUN 03 1993</u>	<u>22 PPG 77</u>
Seal Evaluation:	<u>Pass</u>	<u>JUN 03 1993</u>	<u>22 PPG 77</u>
(Comments) <u>No seal on Broomer</u>			
Visual Inspection: (Place comments on attached sheet)	<u>Pass</u>	<u>JUN 03 1993</u>	<u>22 PPG 77</u>

Air, Delam And Vinly cracks LOCATED ALL  
AROUND UNIT

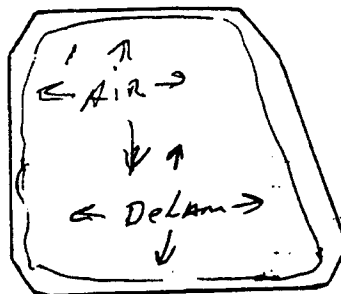
Visual Inspection Map & Comments

1: <u>.687</u> 2: <u>.686</u> 3: <u>.687</u> 4: <u>.685</u>			
Check for Vinyl Cracks:	<u>Acc</u>	<u>JUN 03 1993</u>	<u>22 PPG 77</u>
Seal Evaluation:	<u>ReJ</u>	<u>JUN 03 1993</u>	<u>22 PPG 77</u>
(Comments) <u>NO BUMPER ON OUTSIDE</u>			
Visual Inspection: (Place comments on attached sheet)	<u>ReJ</u>	<u>JUN 08 1993</u>	<u>22 PPG 77</u>

Deep 5/5

B/B Res. 123.2 ~~After~~ before T.I 9/6.8 after T.I

Air ALL AROUND of unit And Also Delam

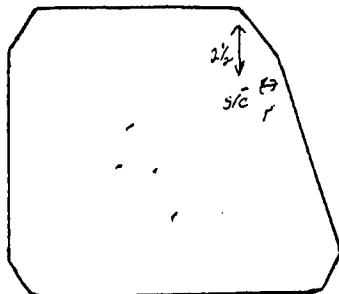
Visual Inspection Map & Comments

1: <u>9</u> 2: <u>5</u> 3: <u>7</u> 4: <u>5</u>			
Dimensional Inspection:			
Unit Thickness: (Per Template)	<u>Acc</u>	<u>5-25-93</u>	<u>82 pdd 77</u>
1: <u>.695</u> 2: <u>.707</u> 3: <u>.712</u> 4: <u>.702</u>			
Check for Vinyl Cracks:	<u>Acc</u>	<u>JUN 02 1993</u>	<u>22 PPG 77</u>
Seal Evaluation:	<u>Rej</u>	<u>JUN 02 1993</u>	<u>22 PPG 77</u>
(Comments)	<u>wrong seal on outbd side of unit</u>		
Visual Inspection:	<u>Rej</u>	<u>JUN 02 1993</u>	<u>22 PPG 77</u>
(Place comments on attached sheet)

SURFACE CHIP LOCATED 2 1/2" IN DOWN AND 1" FROM FWD. EDGE  
AND OTHER SURFACE DEFECTS LOCATED CENTER OF UNIT

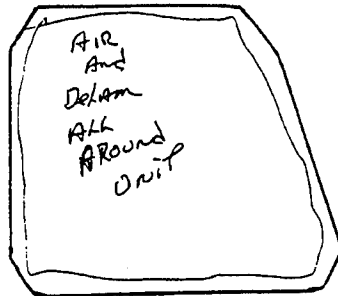
Visual Inspection Map & Comments

1: <u>6.3</u> 2: <u>6.92</u> 3: <u>6.3</u> 4: <u>6.3</u>			
Dimensional Inspection:			
Unit Thickness: (Per Template)			
1: <u>6.92</u> 2: <u>6.91</u> 3: <u>6.93</u> 4: <u>6.93</u>			
Check for Vinyl Cracks: <u>ACC</u>		<u>JUN 03 1993</u>	<u>22 PPG 77</u>
Seal Evaluation: <u>Rej</u>		<u>JUN 03 1993</u>	<u>22 PPG 77</u>
(Comments) <u>wrong seal on outside edge</u> <u>Bumper is bad on outside side</u>			
Visual Inspection:	<u>Rej</u>	<u>JUN 03 1993</u>	<u>22 PPG 77</u>
(Place comments on attached sheet)

AIR And Delam located ALL Around Unit
